UNDERSTANDING AND MITIGATING DOWNHOLE CORROSION AND WEAR FAILURES

Rob Davis
Michael Naguib
Bill Snider
Western Falcon Energy Services

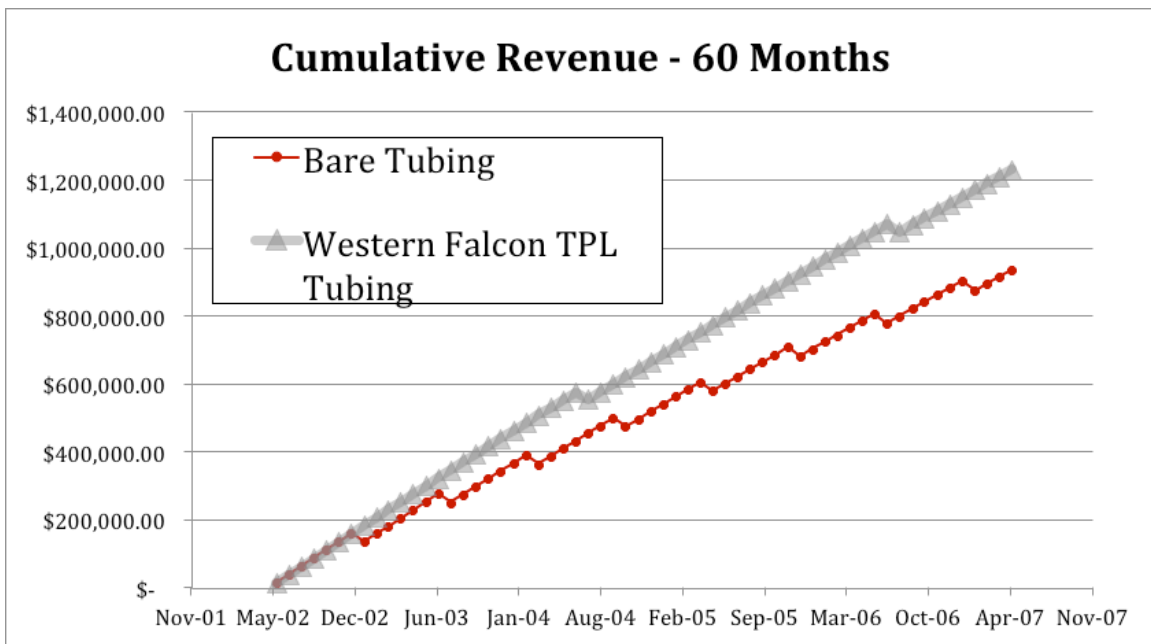
Figure 1 – Comparative Monthly Single Well Revenue Before and After Installation of TPL Tubing For Case Study One

The use of TPL tubing to solve the severe downhole tubular failure issues made this field much more economically efficient to operate. Figures 1, 2, and 3 show the economic return for one well over a five-year time frame. The input data used to generate these figures using a new proprietary downhole runtime economic model is listed in Table 1. Even at an average oil price of 30 USD per BBL of oil and allowing for a pump related workover every 25 months, each TPL lined well yielded an additional 274,000 USD of revenue every 5 years (or approximately 650,000 USD over the 12 year run life in this well) to the operator in increased uptime and reduced workover costs (NOT including energy savings or increased sucker rod fatigue life from reduced rod on tubing friction) at a base cost of under 15,000 USD for the thermoplastic tubing liner. Ironically, the TPL tubing was still in reusable condition after over 12 years of service. It is important to note that the key driver in the economic return figures is accurately finding the product, or combination of products, that maintain the integrity of the completion assets (rods, pumps, tubing, etc.) for the longest service life; because the cost of a single workover often more than offsets the cumulative cost of the solutions. Significant focus is often put on the initial capital expenditure in attempting to

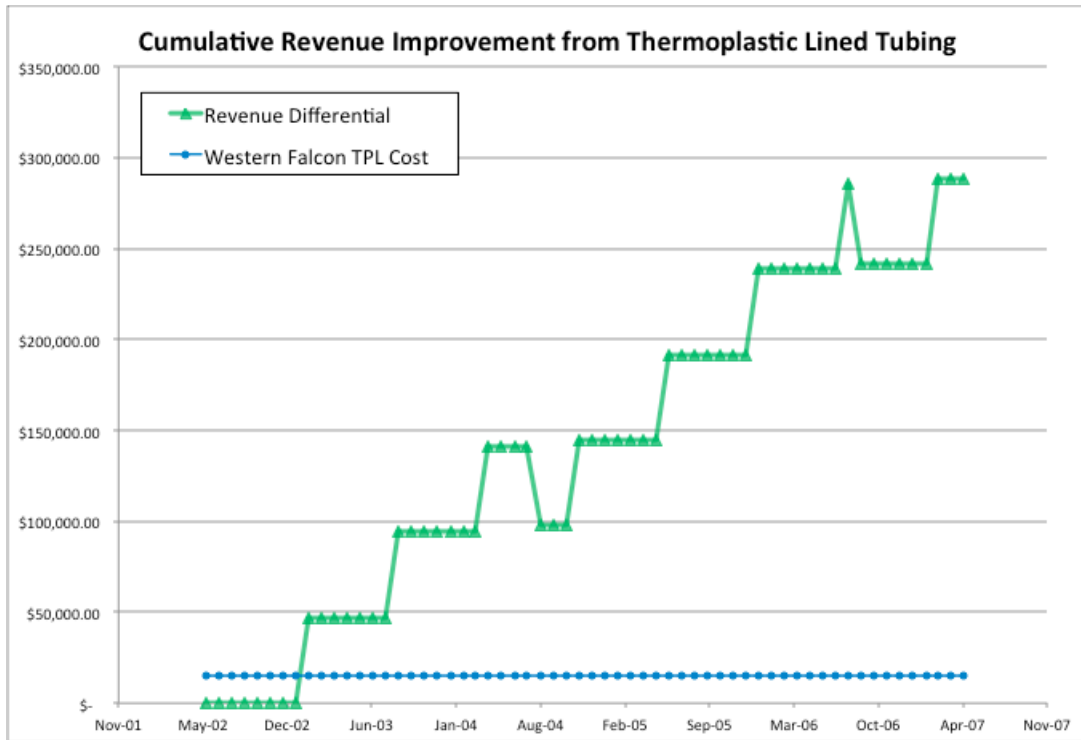
Figure 2 – Cumulative Single Well Revenue Averaging Just Under \$55,000 of Incremental Gain (Over 3.5X the Total TPL Cost) Per Year over 5 Years, Before vs. After TPL Tubing Installation For Case Study One

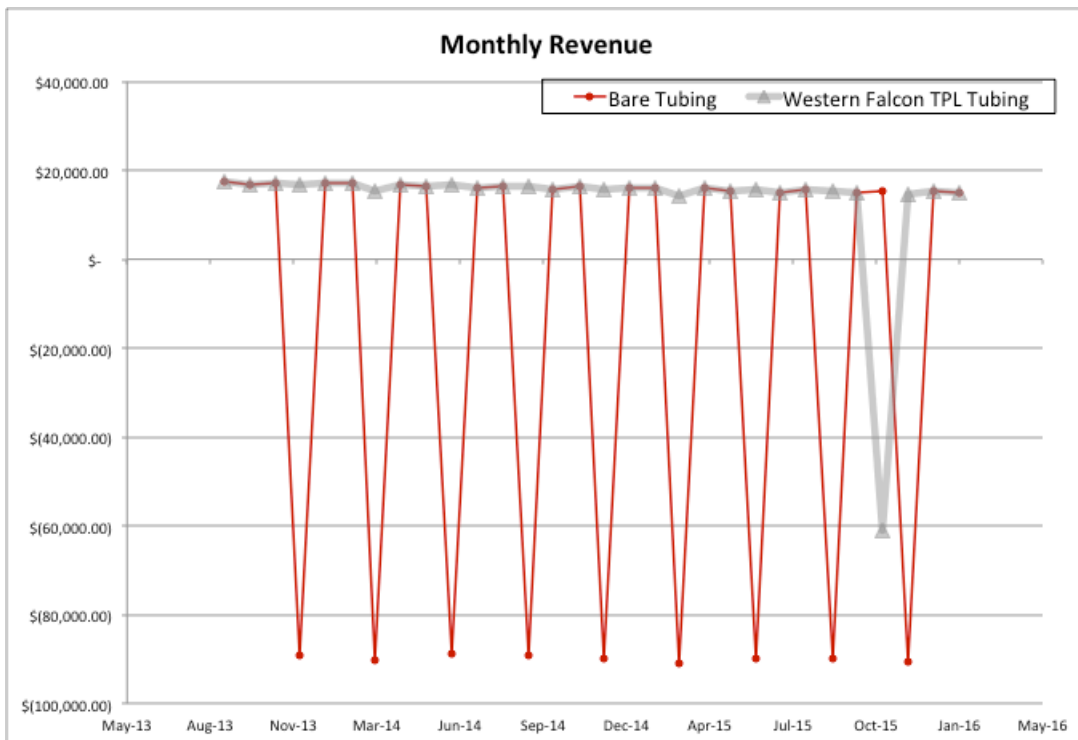
Figure 3 – Single Well Revenue Differential Over 5 Year Period After Installation of TPL Tubing Costing Less Than \$15,000 For Case Study One

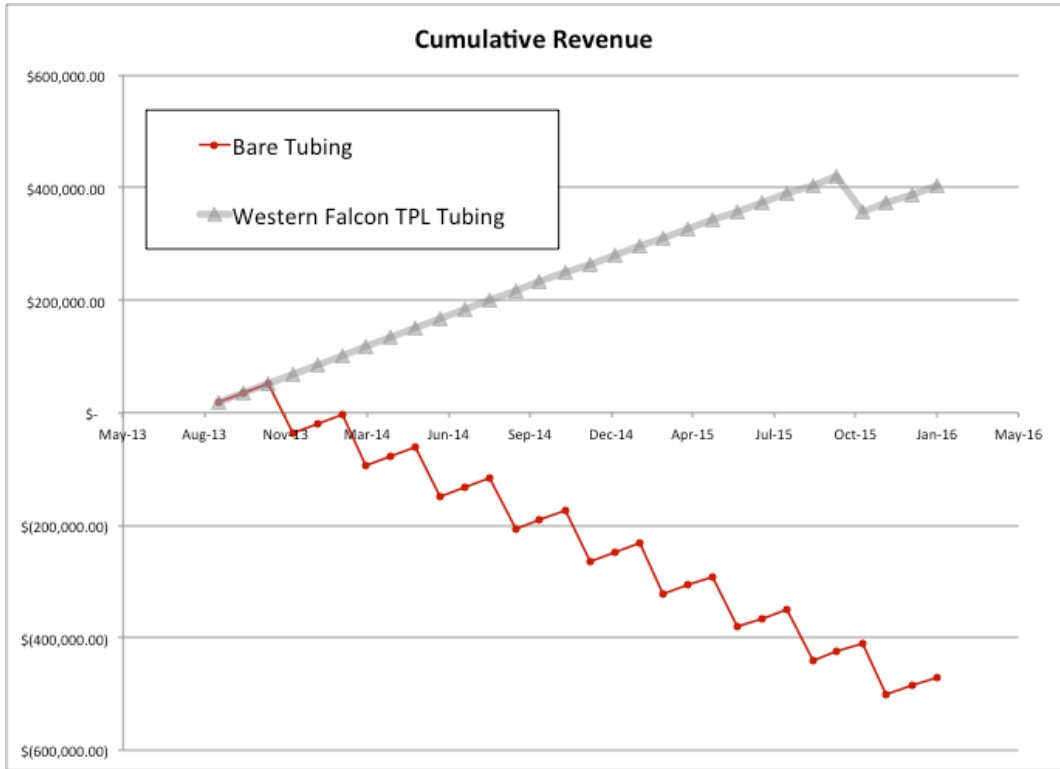
Figure 4 – Comparative Monthly Single Well Revenue Before and After Installation of TPL Tubing For Case Study Two

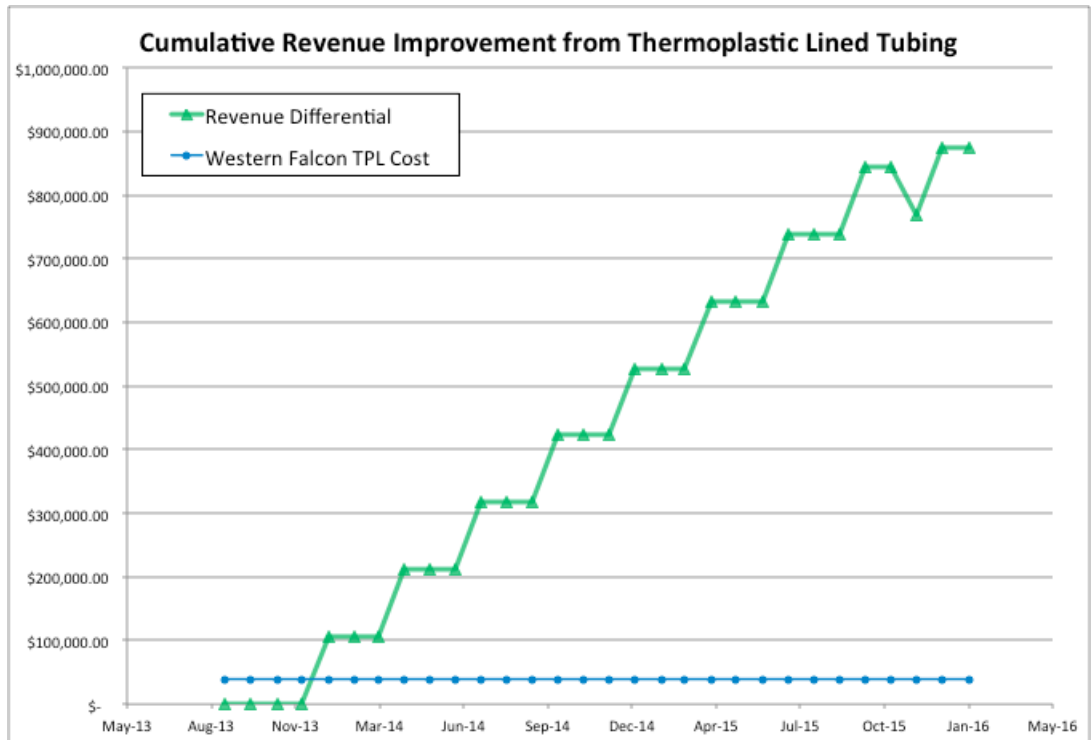
Figure 5 – Cumulative Single Well Revenue Averaging Just Under \$350,000 of Incremental Gain Per Year over 30 Months, Before vs. After TPL Tubing Installation For Case Study Two

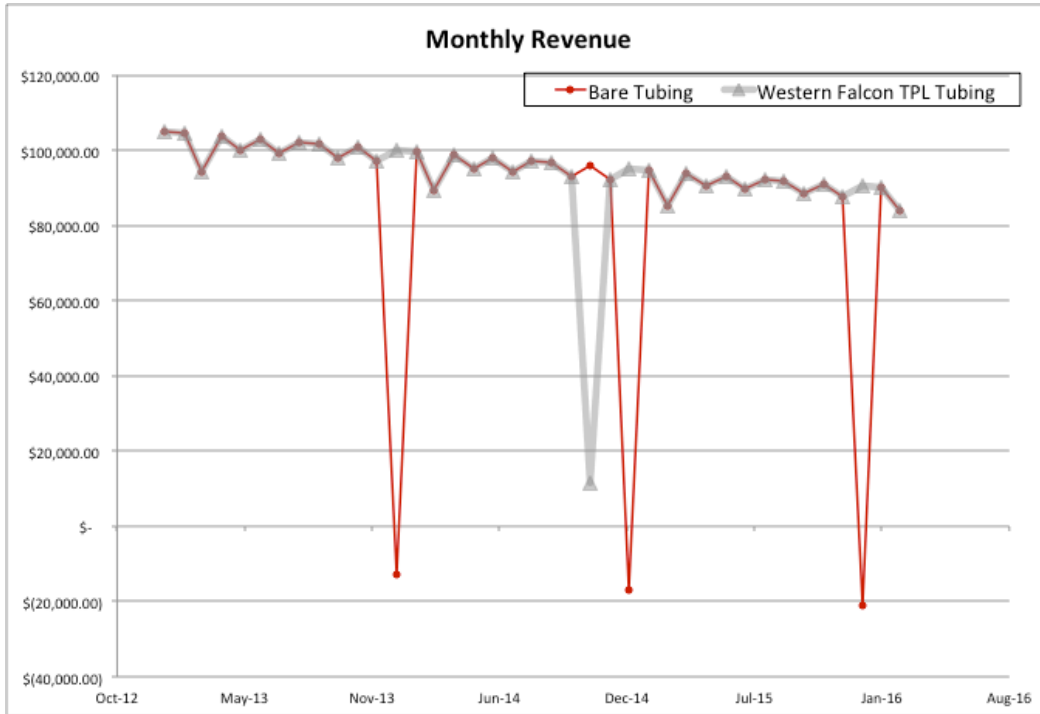
Figure 6 – Single Well Revenue Differential Over 30 Month Period After Installation of TPL Tubing Costing Less Than \$26,000 For Case Study Two

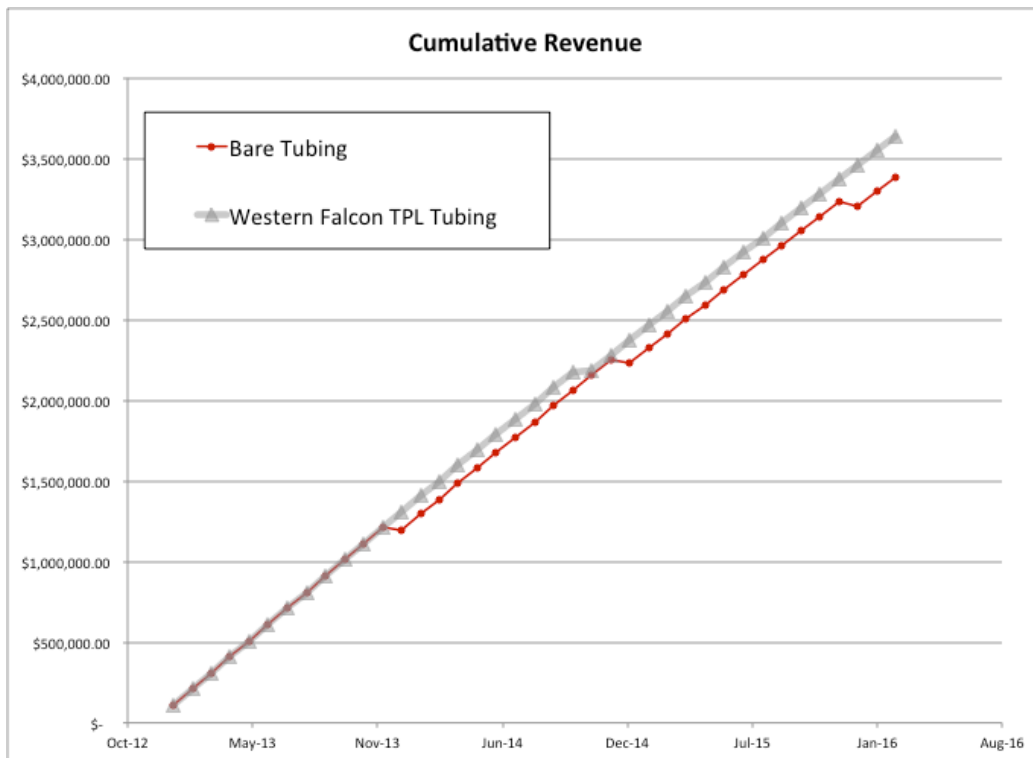
Figure 7 – Comparative Monthly Single Well Revenue Before and After Installation of TPL Tubing For Case Study Three

The data used to generate the economic comparisons for this well shown in Figures 7, 8 and 9 is listed in Table 3 at the end of this paper. After 39 months of operation this well has generated an additional \$250,000 benefit at a total cost of approximately \$30,000 for the TPL. Because some rod on tubing wear was seen in the guided section above the lined tubing, it is speculated that running perhaps as much as 3,000 feet of lined tubing (at an additional cost of approximately \$15,000) may be needed to avoid a potential premature tubing failure as the pump designs improve and provide a longer MTBF.

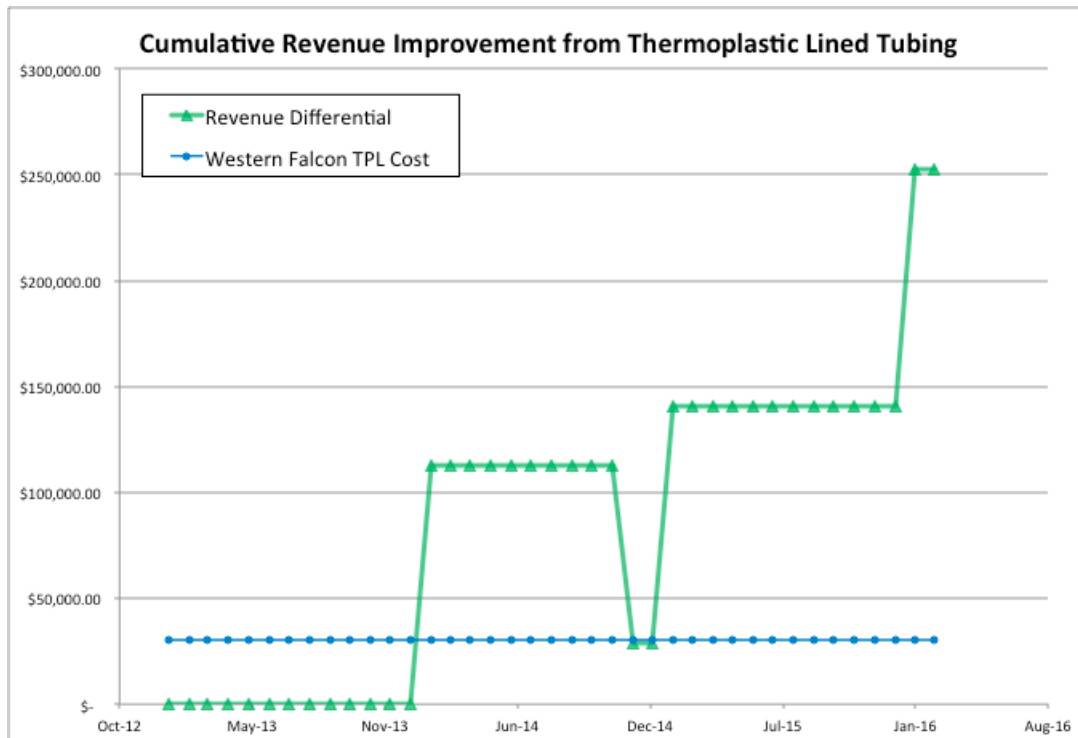
Figure 8 – Cumulative Single Well Revenue Averaging Approximately \$77,000 of Incremental Gain Per Year over 39 Months, Before vs. After TPL Tubing Installation For Case Study Three

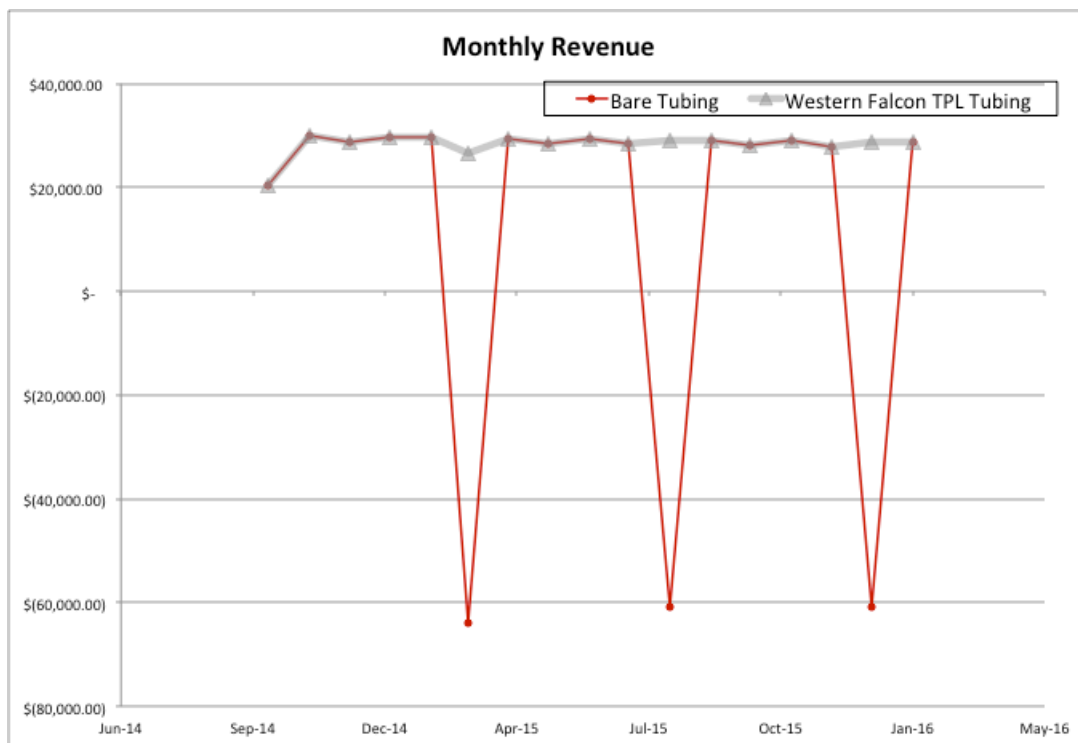
Figure 9 – Single Well Revenue Differential Over 39 Month Period After Installation of TPL Tubing Costing Approximately \$30,000 For Case Study Three

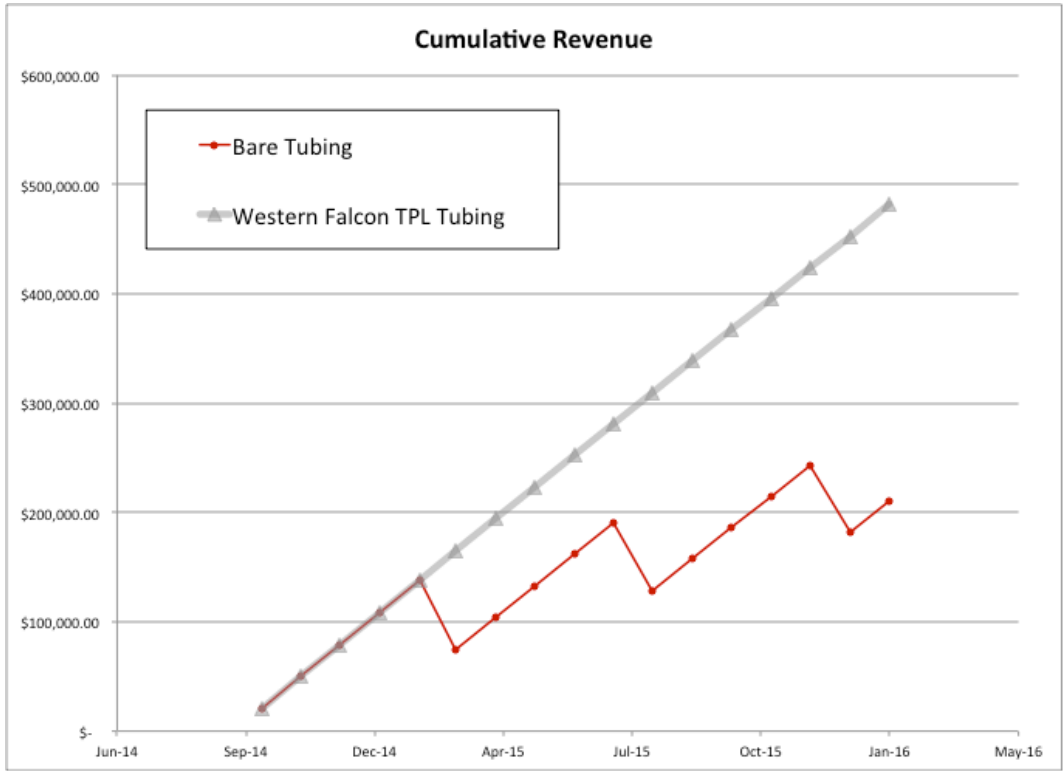
Figure 10 – Comparative Monthly Single Well Revenue Before and After Installation of TPL Tubing For Case Study Four

The data used for the 17 month economic comparisons illustrated in Figures 10, 11, and 12 is listed in Table 4. The incremental cost increase for the modified TPL in these wells is approximately \$10,000 per well. In the 17 months of service for this one well, the improved completion design has yielded a benefit of approximately \$260,000. Currently, the average annual benefit of the TPL is over \$183,000 per well, which is over 18X the entire incremental cost increase of the TPL. It should be noted that this well has not yet failed (pump still operational after 17 months) and it is expected that the pump could fail at anytime thereby reducing the benefit by approximately \$35,000 (the estimated cost of a rod workover) at that time. The operator reports that due to the additional well uptime alone, the same field is producing over 10,000 BPD more (from the same number of production and injection wells) than when it first started using TPL tubing and currently averaging fewer than 8 failures per month (down from over 32). These results have been realized by deploying TPL tubing in approximately one-third of the field's producing wells to date.

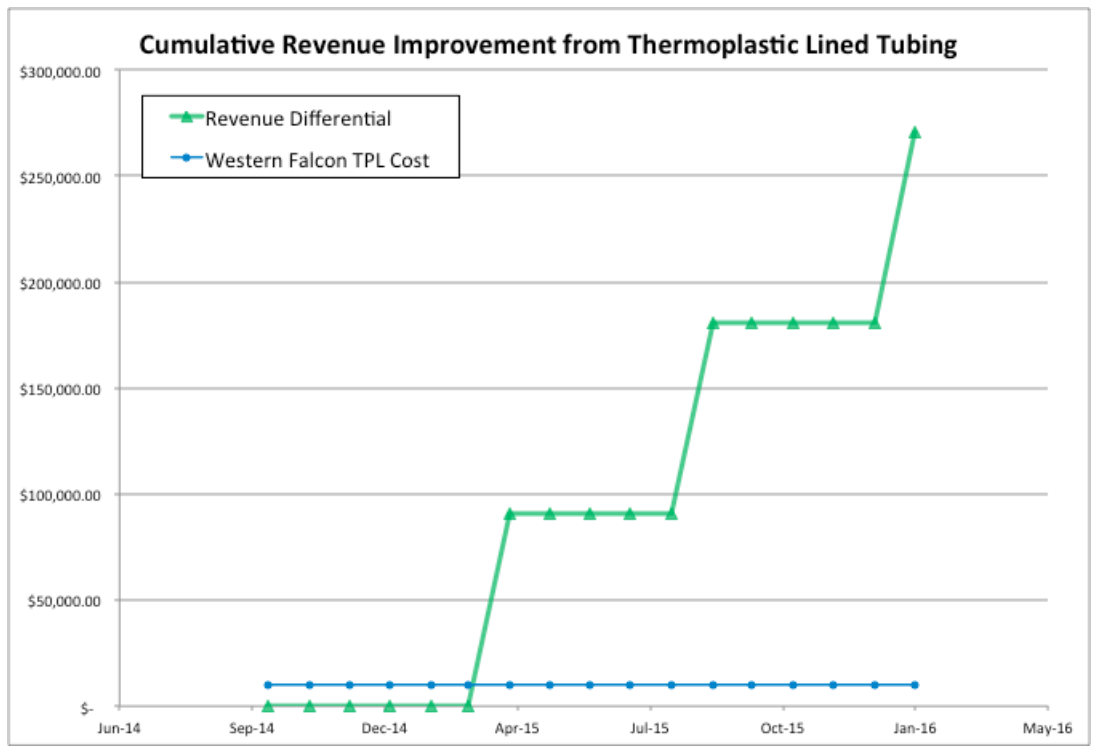
Figure 11 – Cumulative Single Well Revenue Averaging Over \$183,000 of Incremental Gain Per Year over 17 Months, Before vs. After TPL Tubing Installation For Case Study Four
